**BROOKVILLE LAKE
GREATER MIAMI RIVER BASIN
INDIANA**

**EMBANKMENT CRITERIA AND
PERFORMANCE REPORT**

**PREPARED BY
U.S. ARMY ENGINEER DISTRICT, LOUISVILLE
CORPS OF ENGINEERS**

SEPTEMBER 1982

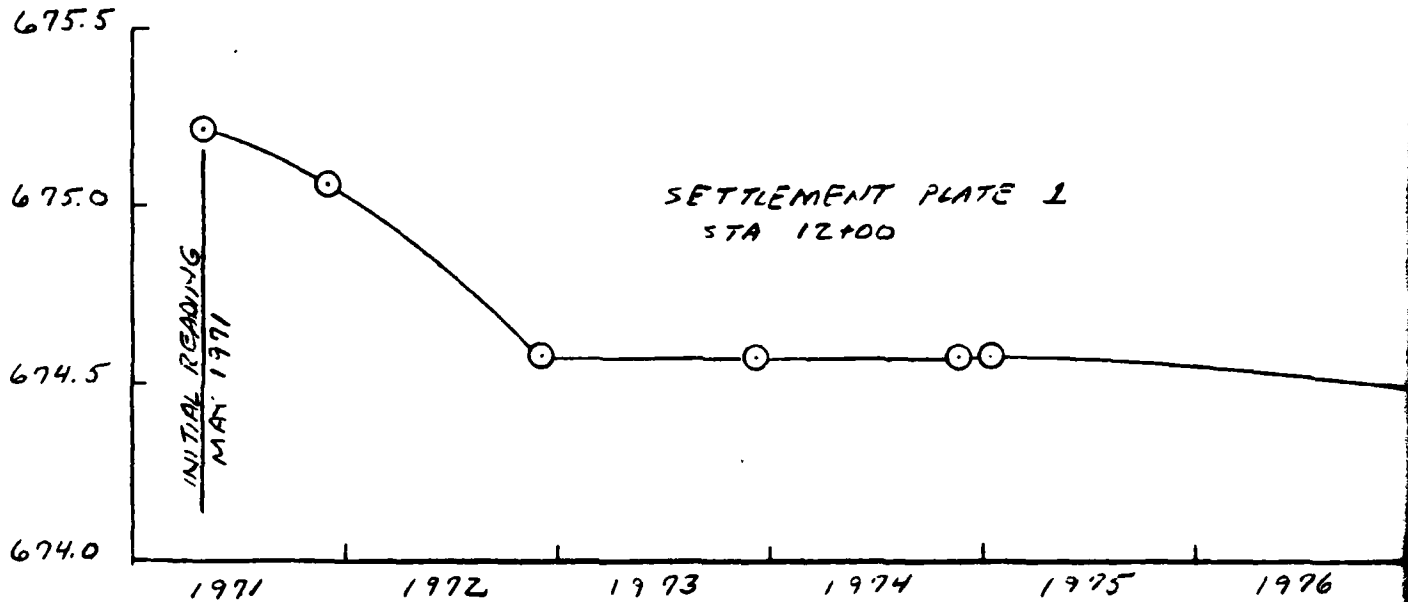
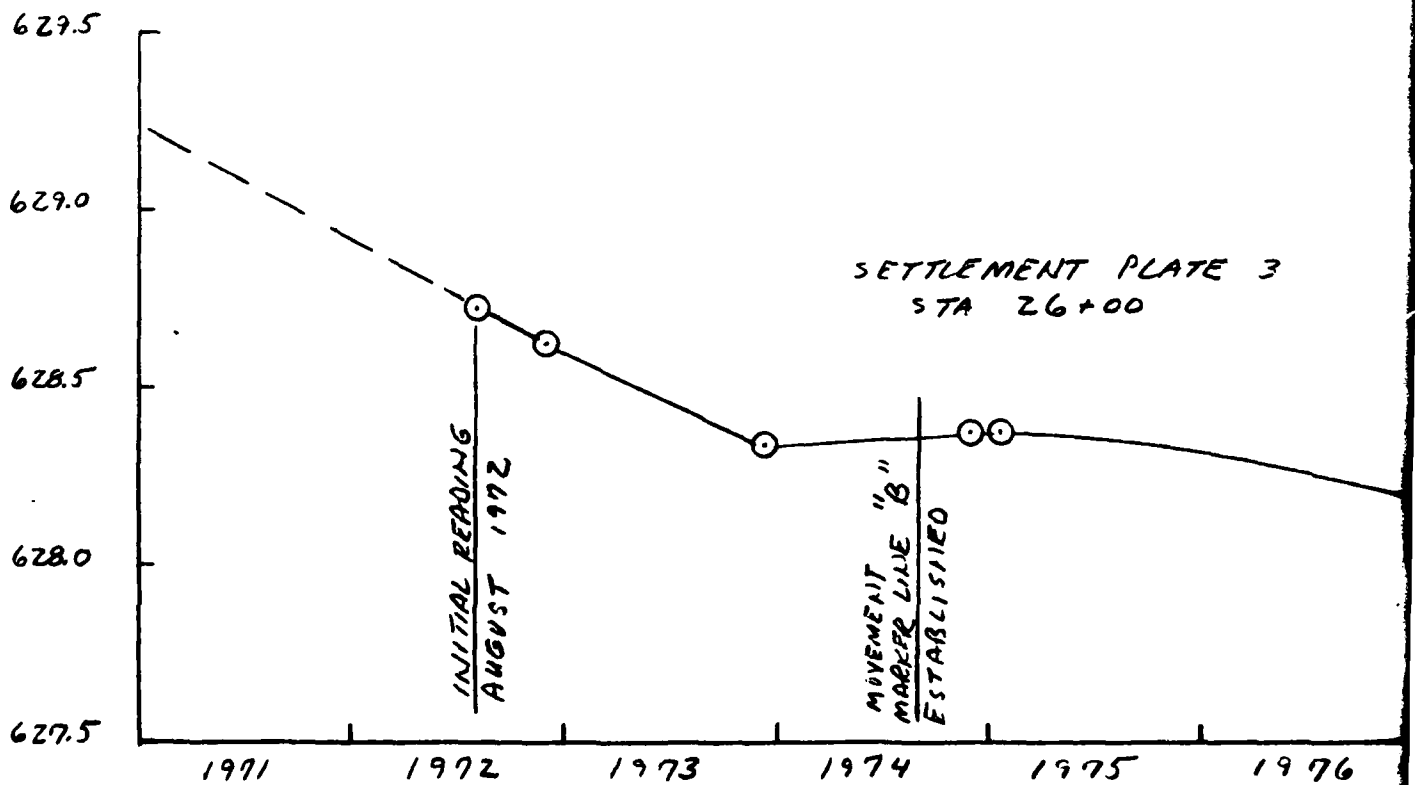
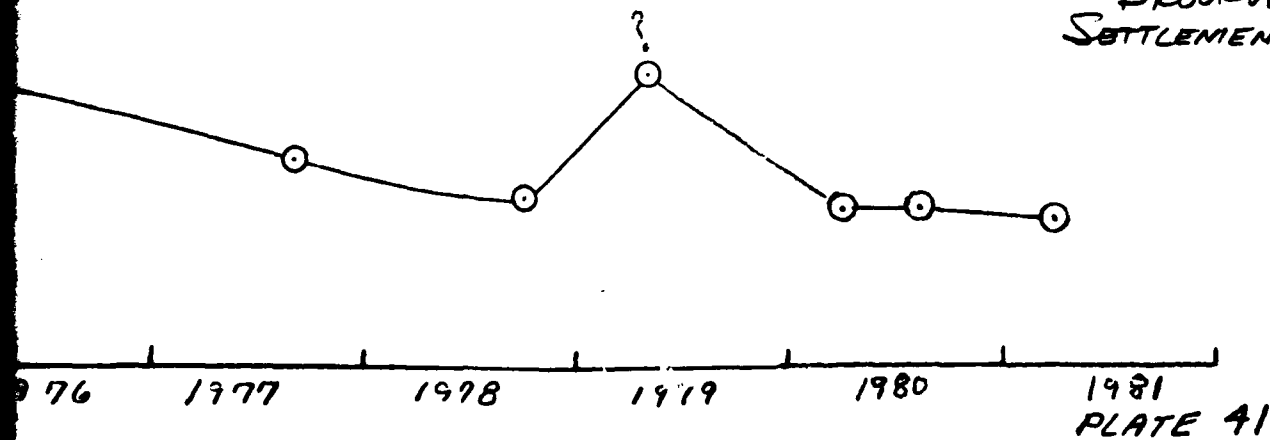
PLATE 41

SETTLEMENT PLATES

BROOKVILLE LAKE
SETTLEMENT RATES

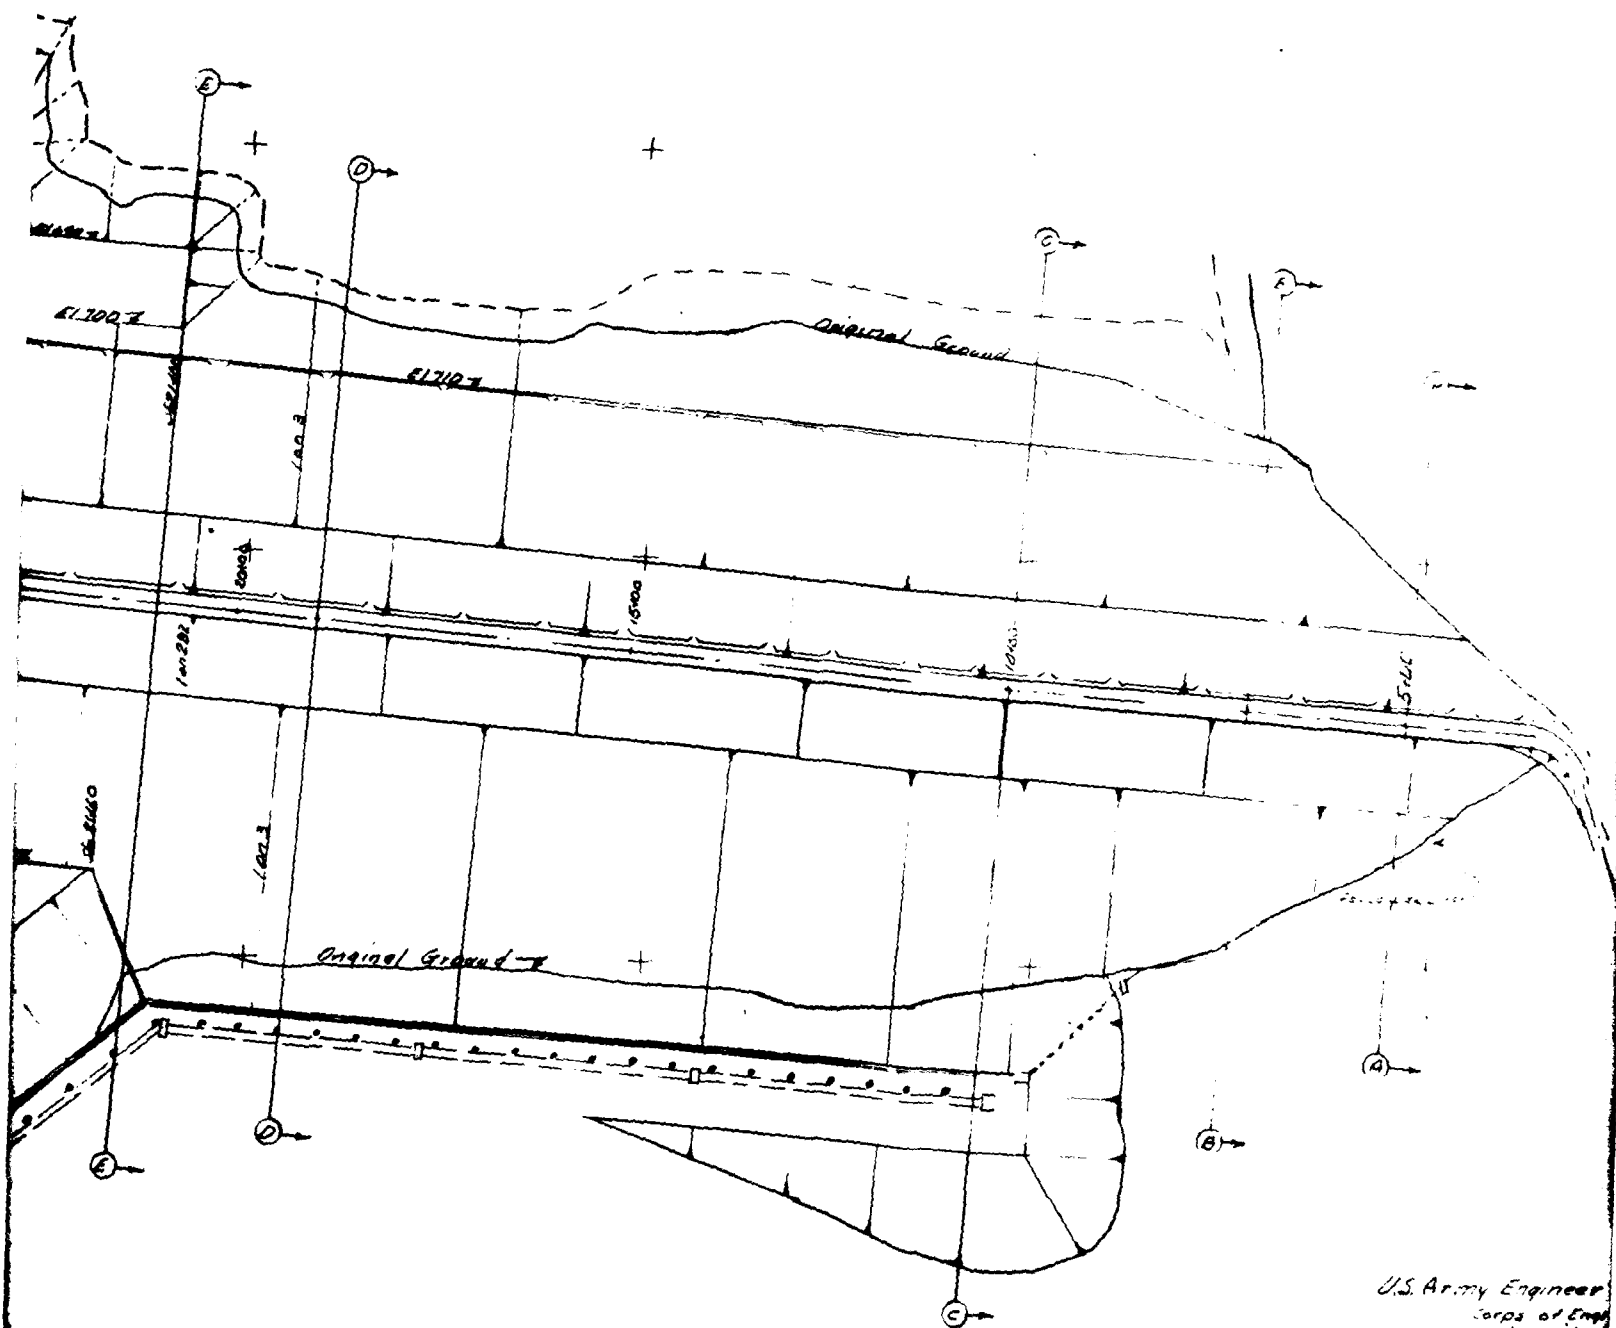
U.S. Army Engineer
Corps of Engineers
Louisville, Ky.
Miami River
Brookville, La.
Brookville, La.
General Plan De

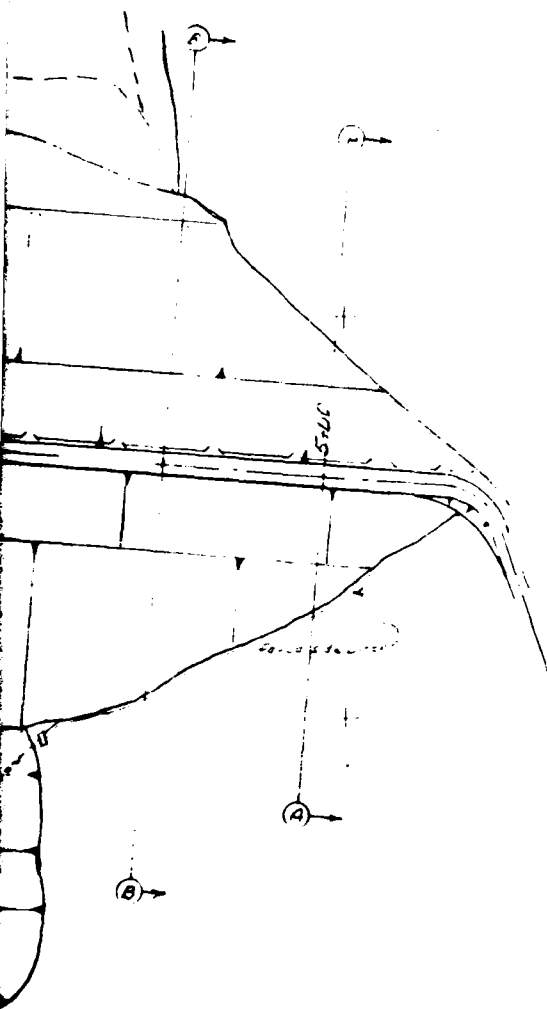
Plate No.

U.S. Army Engineer District, Louisville
Corps of Engineers
Louisville, Ky.
Miami River Basin
Brookville Lake Dam
Brookville, Ind.
General Plan Dam Embankment

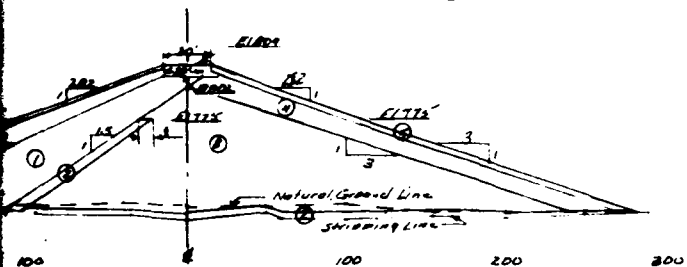
Section H-N
Sta 29100

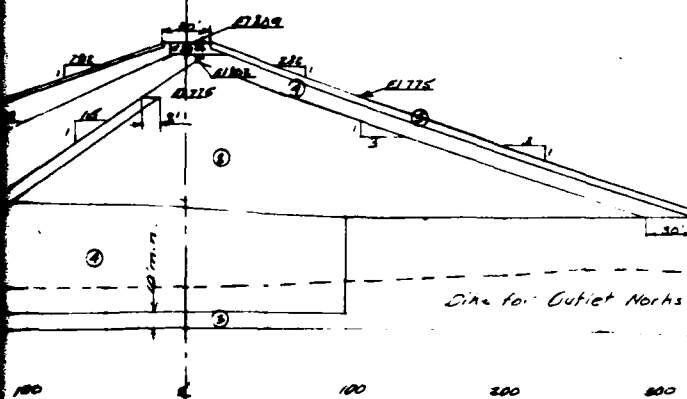
Section G-G
Sta 28100

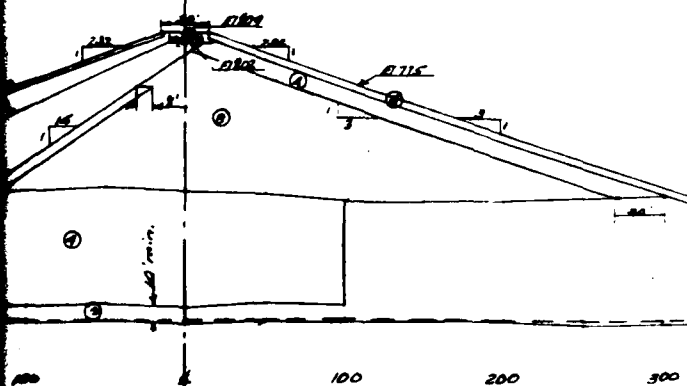
Section F-F
Sta 28100

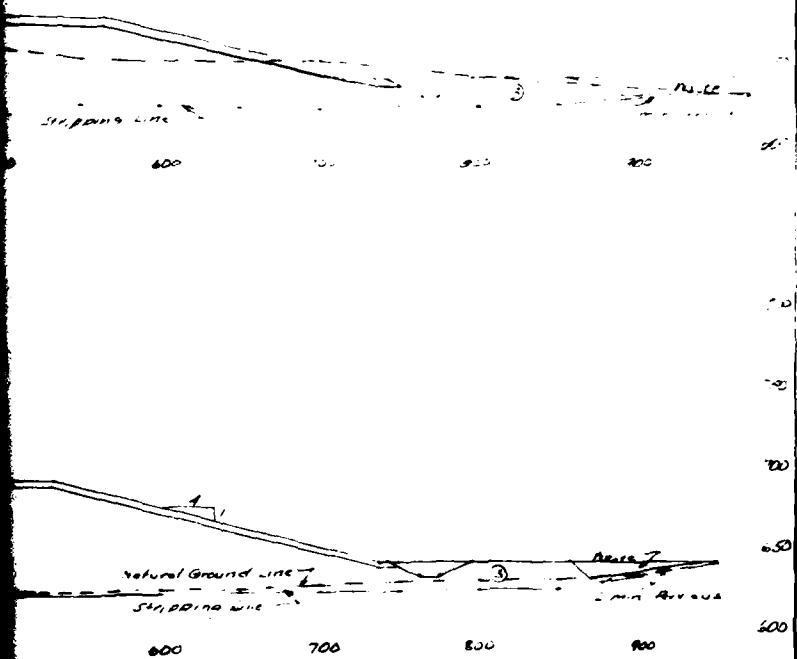
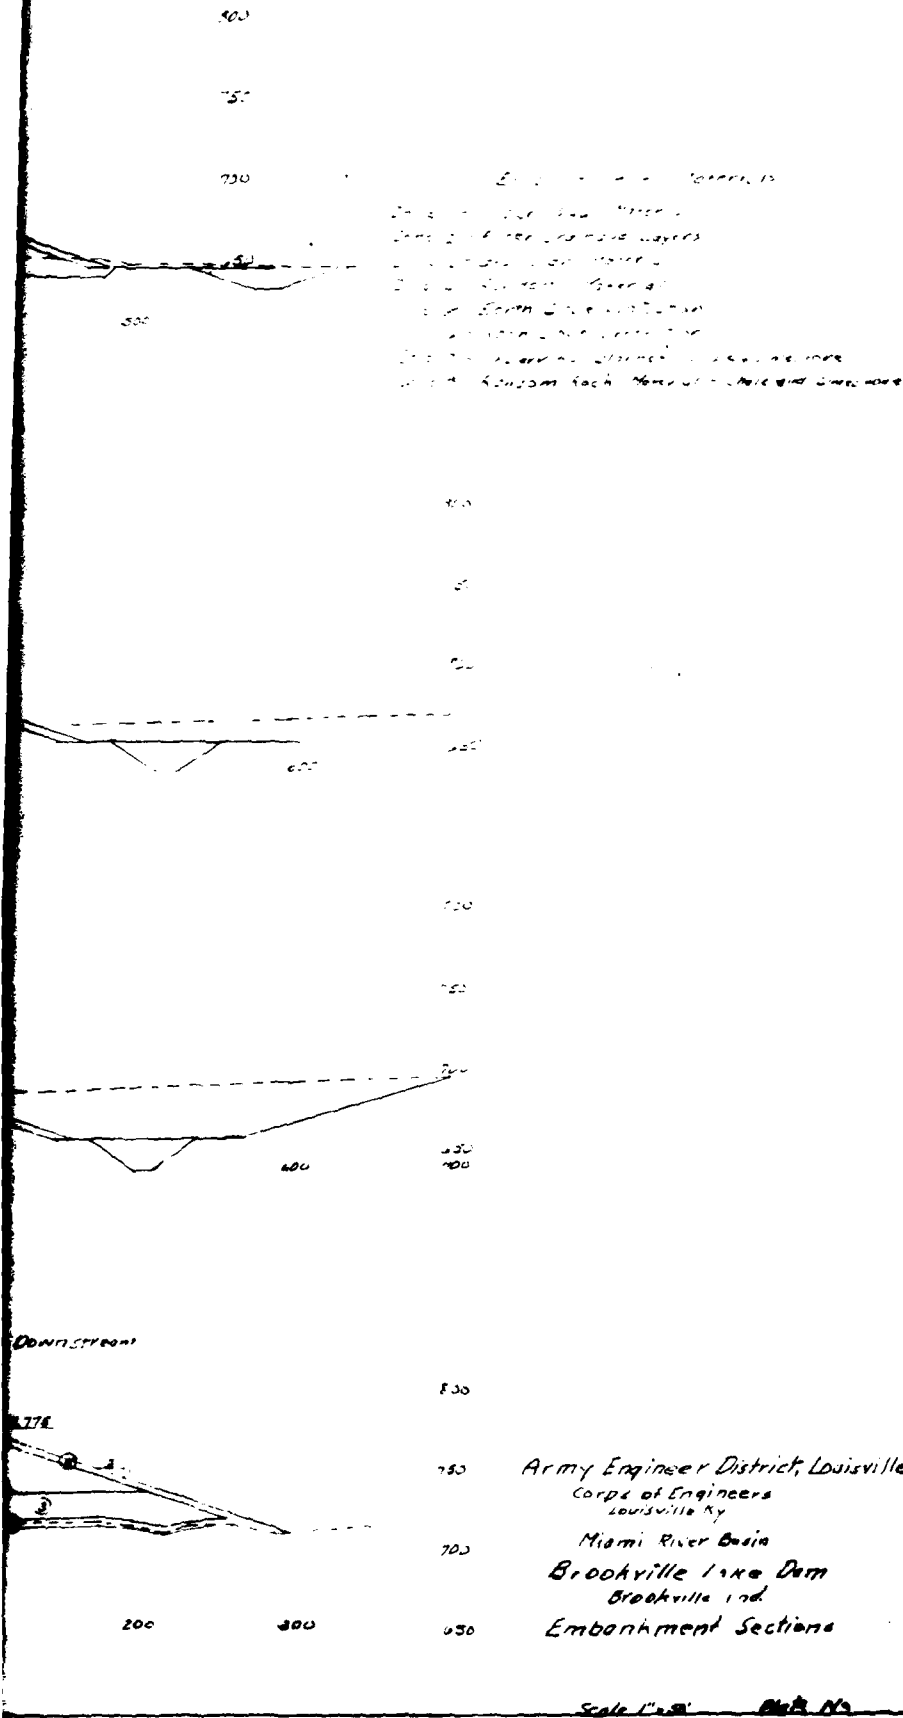
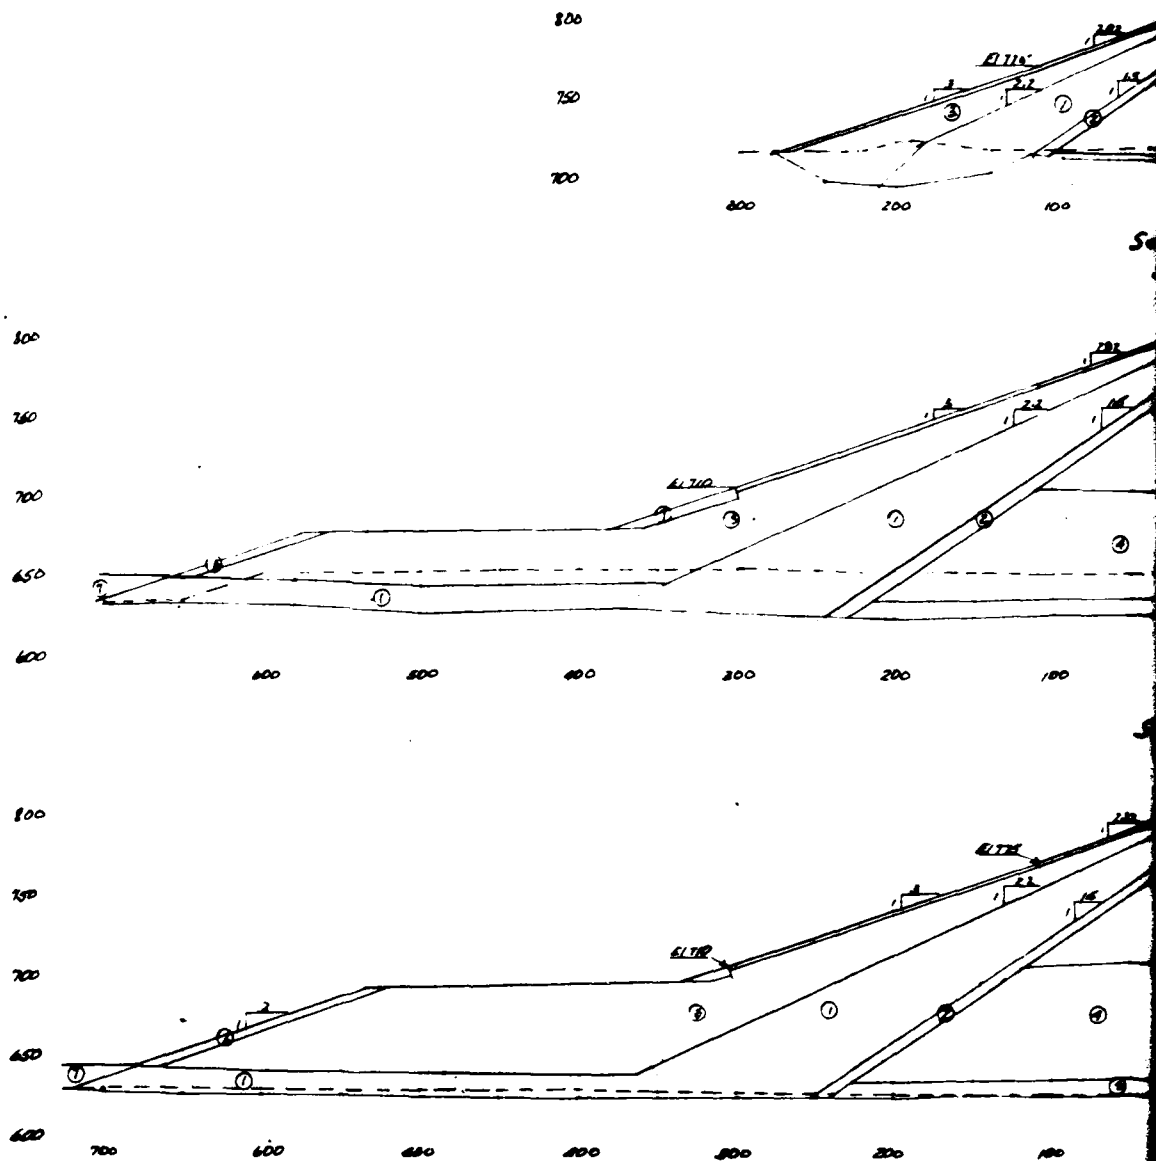
EMBANKMENT SECTIONS

U.S. Army Engineer District, Louisville
 Corps of Engineers
 Louisville Ky
 Miami River Basin
 Brookville Lake Dam
 Brookville, Ind
 Embankment Sections

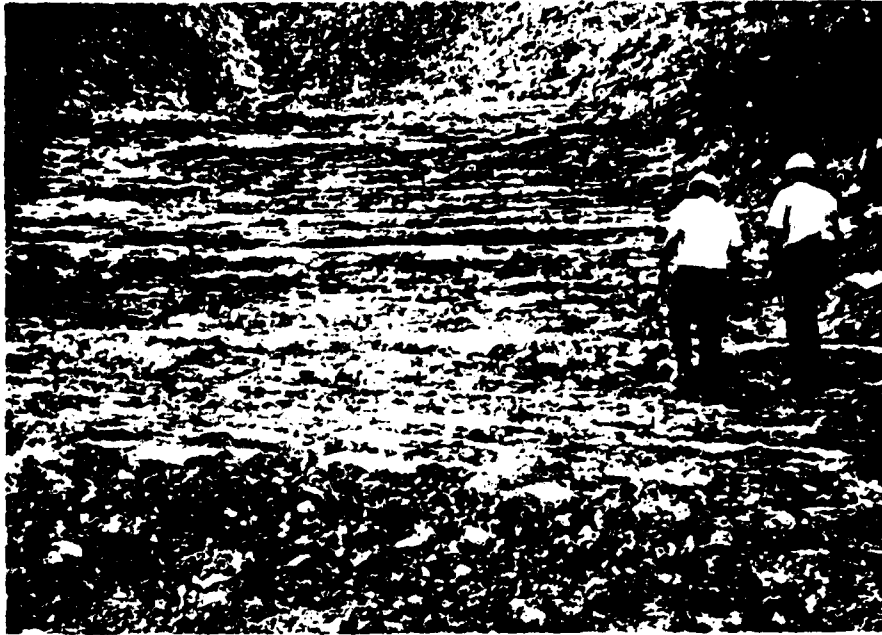
7. Typical right abutment cutoff trench foundation (5/27/72).

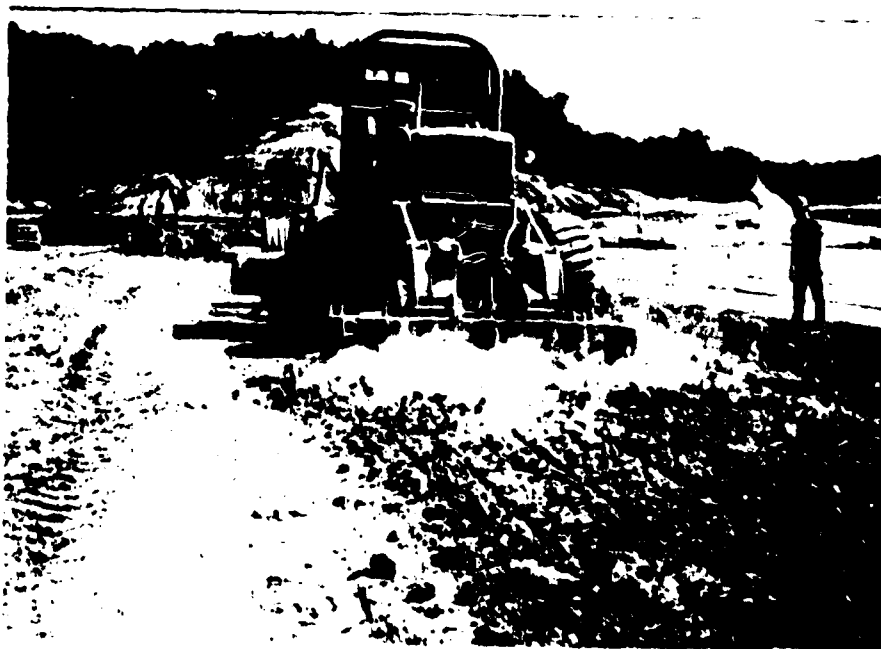
8. Disking dry impervious fill material (9/1/70).

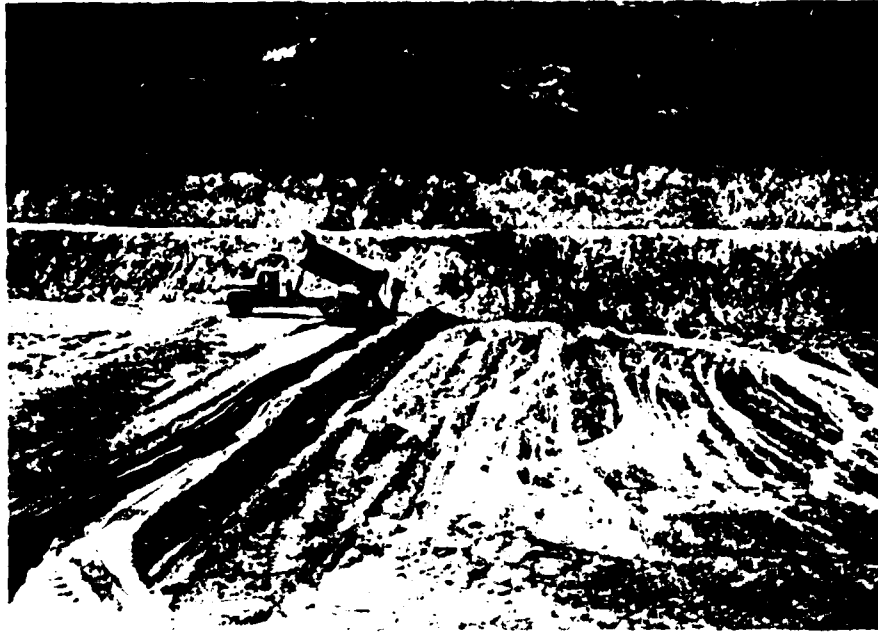
9. Typical operation of placing incline drain material (9/1/70).

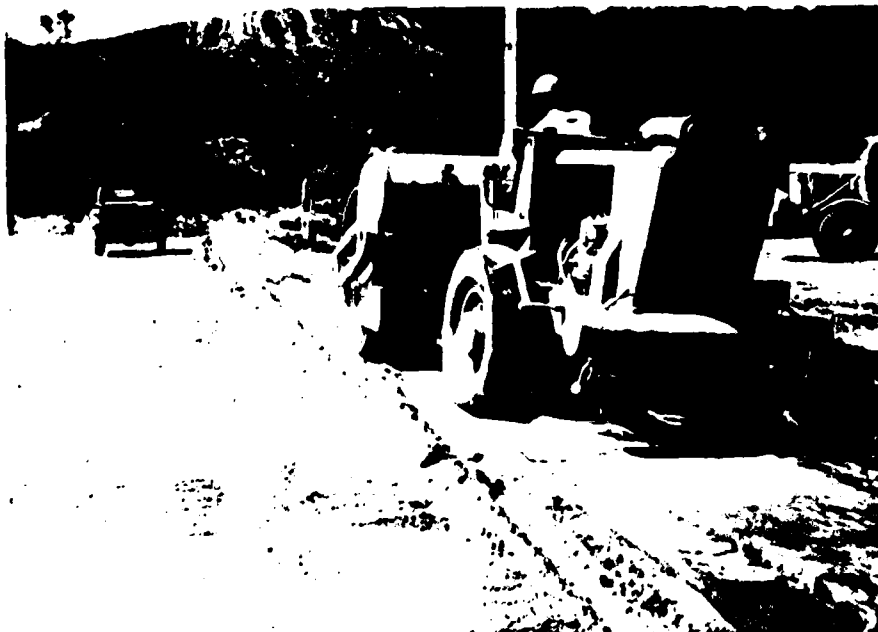
10. Rolling incline drain material @ Station 17+00 (9/1/70).

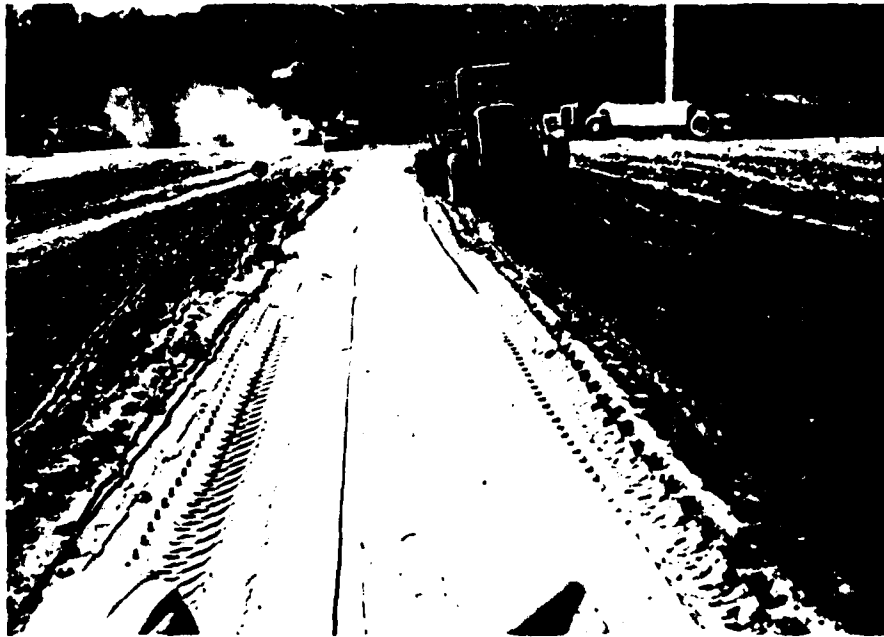
11. View of inclined drain zone after being rolled (9/1/70).

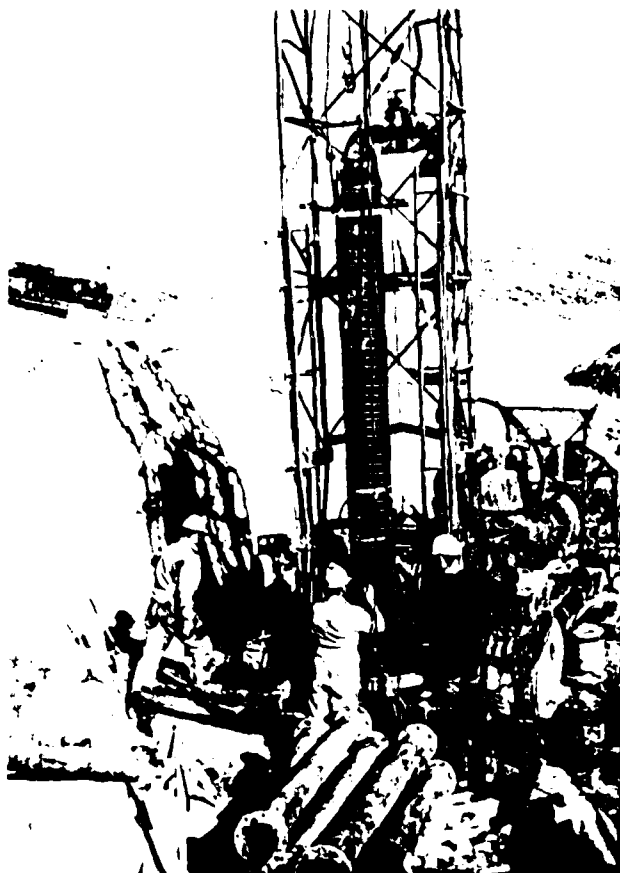
17. View of installing
a relief well screen
(Feb. 71).

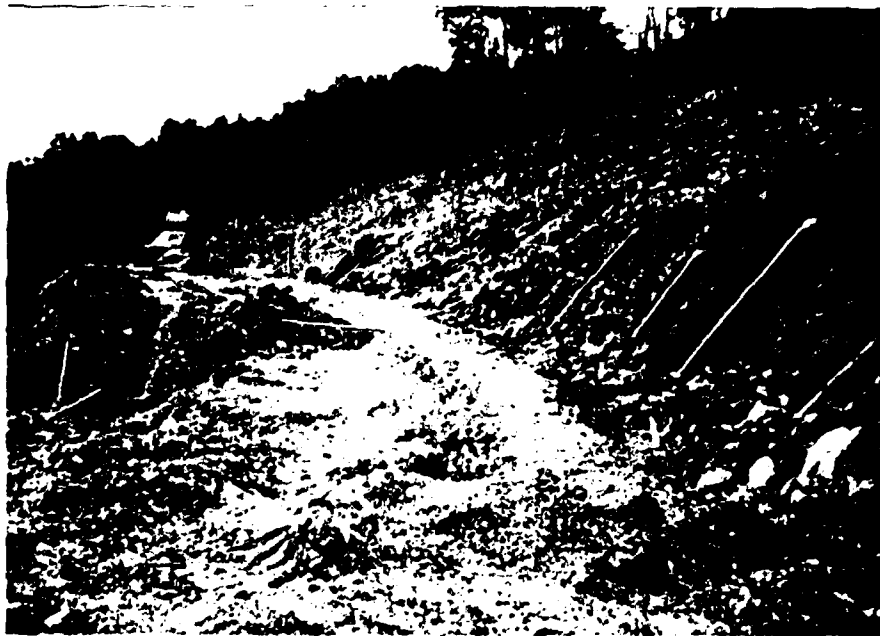
19. View of collector drain pipes for horizontal drains installed in abutment on right side of stilling basin. The bench is elevation 700 (10/1/75).

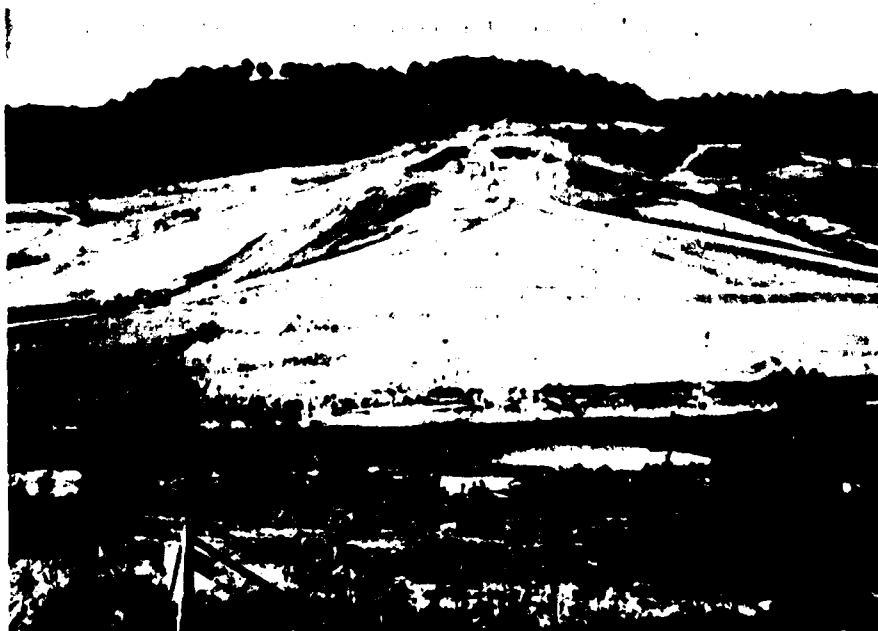
22. View from E dam Station 32+50 looking back station (6/17/72).

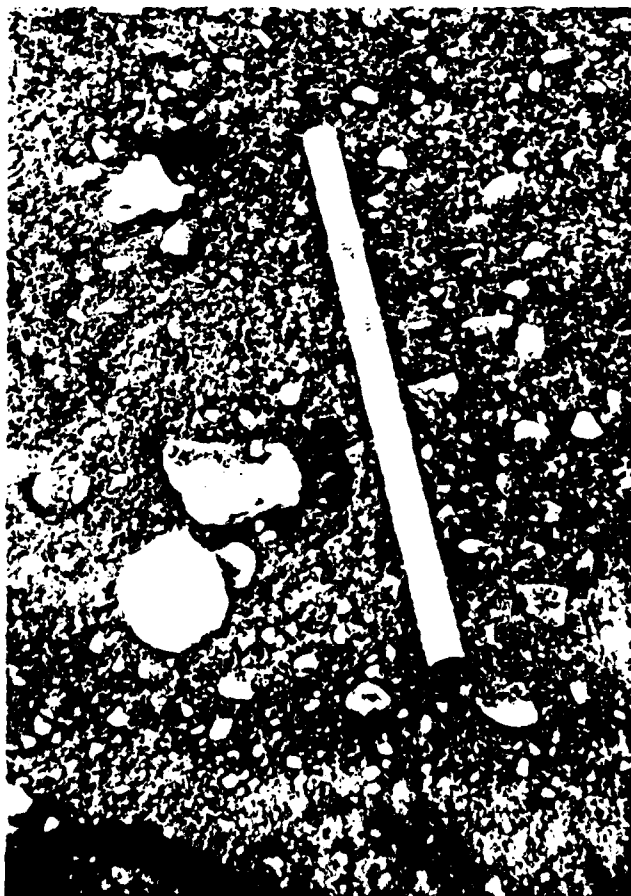
26. Typical 2-foot long porous stone piezometer installed in embankment (4/29/71).
